Check Valve Success Story

The Application: Cooling Tower Chilled Water

The Problem: Original swing check valve lasted only a few months

The Solution: 14" DFT GLC® with a light cracking pressure spring

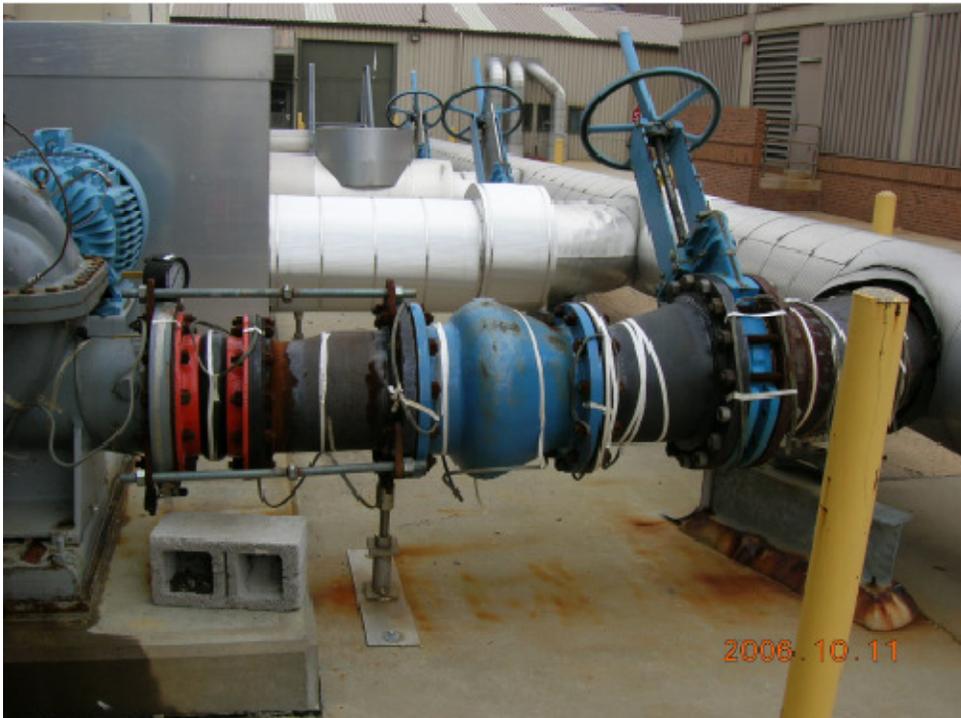
Pump 1, shown in the foreground, is the primary pump which operates continuously during the heating season. It is a variable speed pump which operates between 2100 GPM and 5700 GPM. As the pump runs up into the high range, pump 2 kicks in. You can see the maintenance pump, pump 3, in the background.

Shortly after start up (approximately 2 months), the check valve on pump 1 failed and needed to be repaired. Not long after that, the check valve on pump 2 failed. The end user called in the swing check manufacturer who responded that the valve was mounted too close to the pump ... therefore, there was no warranty.

A quick analysis revealed that the swing check valve was never fully open and stable. Since it was mounted adjacent to the pump, the swing check disc would flutter in the agitated fluid stream, causing excessive wear and rapid failure of the pin. This is a common problem when variable speed pumps are being used since minimum flow velocities in the 10-12 feet per second range are needed to keep a swing check disc stable in agitated flow.

DFT recommended a 14” **GLC®** with a light cracking pressure spring for the application. The light cracking pressure spring allows the valve to open fully in a low flow condition (as low as 3 feet per second). When the valve is fully open, the disc does not oscillate in the turbulence, and wear does not occur.

After replacing the valve on pump 2, the end user reported that the **DFT Silent Check** has operated flawlessly since installation. As you can see, they subsequently replaced the swing check on pump 1 with another **DFT Silent Check**. They are planning to replace the swing check on pump 3 when it fails.
